FERNDALE AVENUE
FLOOD RISK INVESTIGATION

London Borough
of Hounslow

PREPARED FOR THE LONDON BOROUGH OF HOUNSLOW

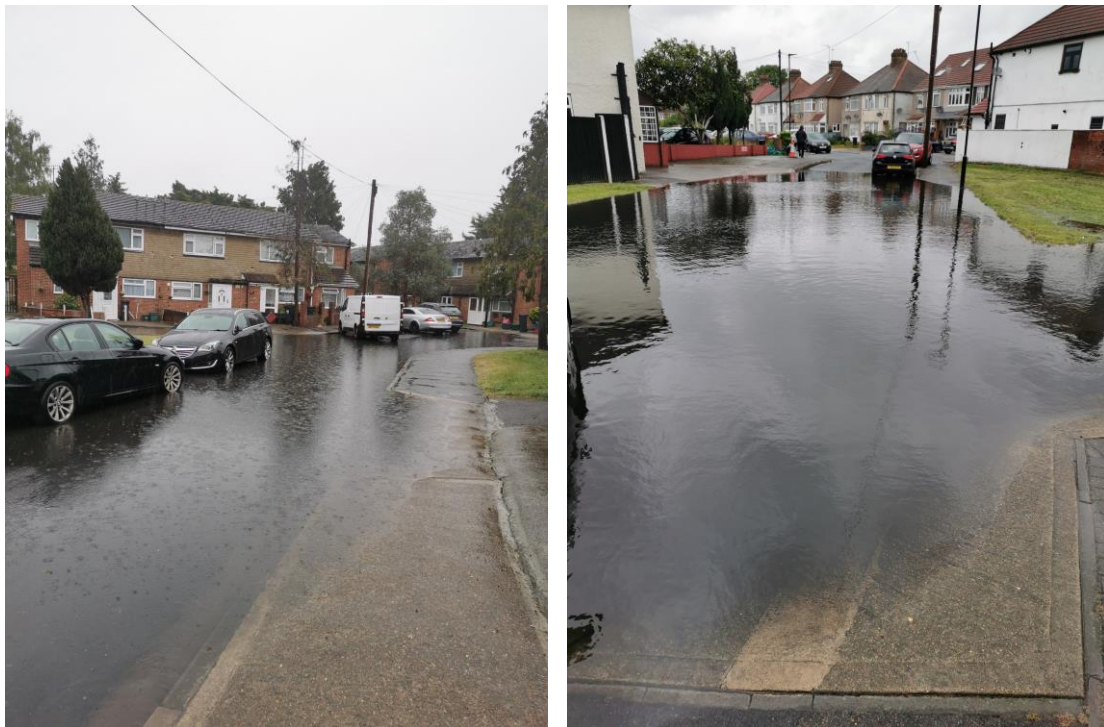
Figure 2-1 Flooding on Ferndale Avenue on 10th and 13th June 2019 respectively
Source: Resident of Ferndale Avenue

Photographs provided by a resident, taken on 10th and 13th June 2019, show the flood water ponding at the end of the Ferndale Avenue cul-de-sac and extending towards the garages (Figure 2-1). No information on flood depth was provided at the time as part of the reports, however photographs show water up to, and in some instances, over topping the curb.

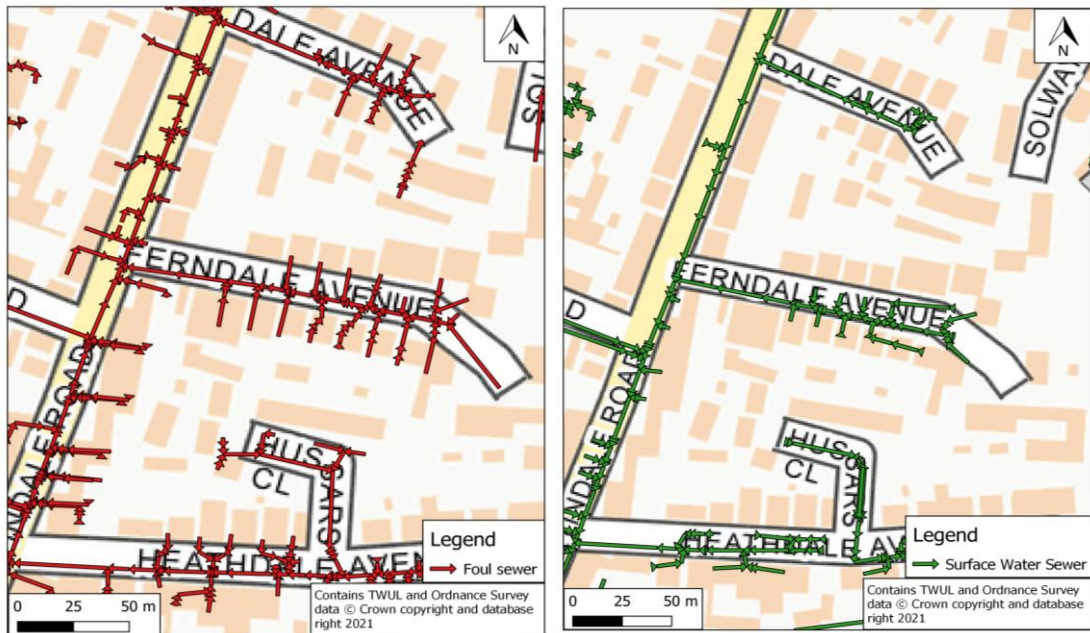
Figure 3-4 Surface and foul water sewer networks in Ferndale Avenue

TWUL are the RMA responsible for the surface water and foul water sewers within the borough. Figure 3-4 shows both the surface and foul water sewer networks in the vicinity of Ferndale Avenue. The surface water network starts outside No. 33 Ferndale Avenue and does not extend into the newer development at the eastern end of the highway. The surface water network drains west towards Martindale Road where it joins a surface water sewer of the same size (225mm diameter) and flows south. The foul water network extends along the entirety of Ferndale Avenue, flowing west where it joins a larger 225mm diameter pipe in Martindale Road, flowing north to Bath Road.
