# London Borough of Hounslow

## Mogden Sewage Treatment Works

### TW Site Inspection

<b>Date of inspection:</b> 16 <sup>th</sup> March 2017	
<b>Attendees:</b> Mr A Robinson (LB Hounslow) & Mr Manzoor Hussain (Thames Water).	
<b>LB Hounslow Observation</b>	<b>Thames Water Action / Response</b>
<p><b><u>Storm Water Storage Tanks (SWST)</u></b></p> <p>All hoppers on Tank 2A were half full and needed over pumping. The tank was being hosed down at the time of the inspection.</p> <p>Hopper 1 in tank 3A was full with thick sludge and required over pumping.</p> <p>Hopper 1 in tank 8A was full with final effluent.</p> <p>All other tanks and hoppers were empty and clear.</p> <p><b><u>Storm Water Channel</u></b></p> <p>The storm feed channel serving STW's 1A-8B was low with no significant build-up of sludge.</p>

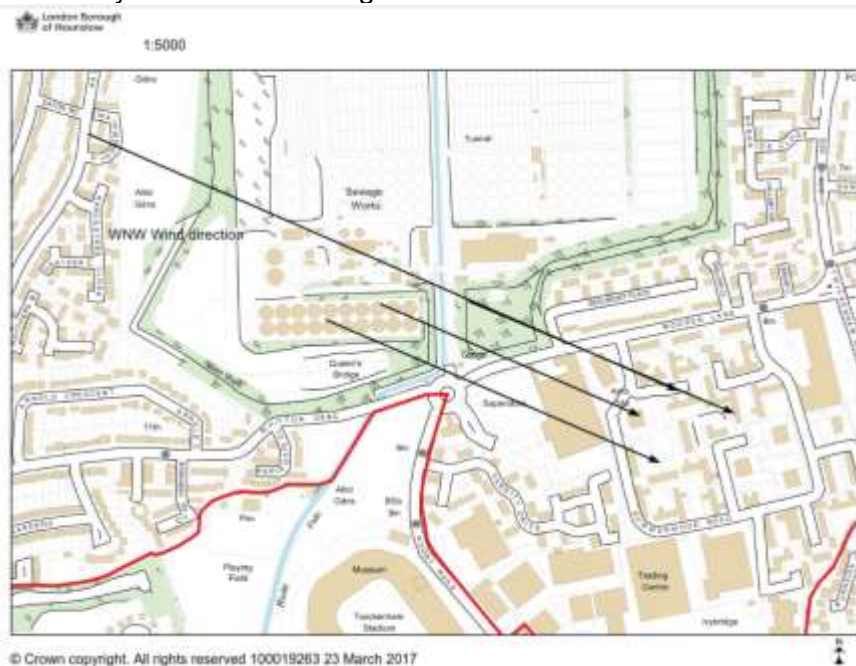
Map illustrating wind direction on 13<sup>th</sup> March 2017 at 11:50.

The site odour log (AM) for this date makes the following observations: No 9 monitor spiked to max of 0.033ppm @ 15:40 30 min max. No. 8 spiked @ 16:50 to max of 0.033. Actions taken: Area checked at digester road and main gate. No obvious smells found. The weather conditions on 13<sup>th</sup> March at 11:50hrs were overcast with moderate wind from a West-Northwest direction and a temperature of 5°C. This may have carried odour from the works towards Summerwood Road. Potential sources of odour from this part of the plant are the digesters, raw sludge handling area or pasteurisation plant. There were no reported problems with any plant on this day. It is difficult to identify the source of odour on this occasion but the digesters are in relatively close proximity to Easedale House and the prevailing wind would have carried any odour from the digesters in this direction.
